Manhole Inspection Summary

Manhole # S17G__018MH

Inspection ☐ Is Incomplete Rating: **4) Poor**

Location Address: **101 WARWICK AVE**

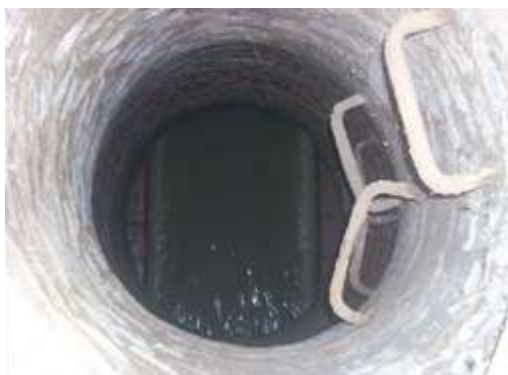
Top View

Comments **ORIGINALLY INSPECTED 3-20-08. TOOK NEW PHOTO TO SHOW
CRACKED/DETERIORATED CHIMNEY 1/2/09**

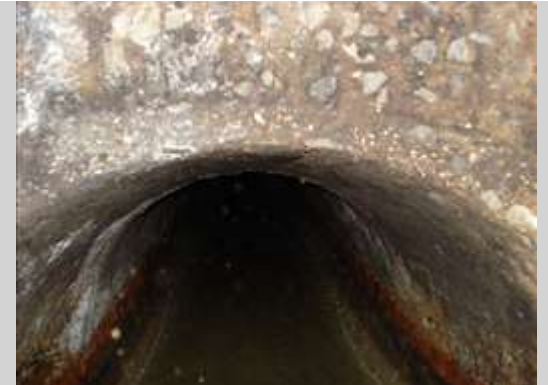
12 O'Clock Outflow

36 in. Circular Gravity Sewer
Pipe Out @ 12 O'Clock

Infiltration: **None** Pipe Seal Cond: **Sound**
